A PROBLEM WITH NORMALIZING STEEL:

METALLURGICAL ANALYSIS OF AIRCRAFT SEAT HANDLE (flight Hardware)

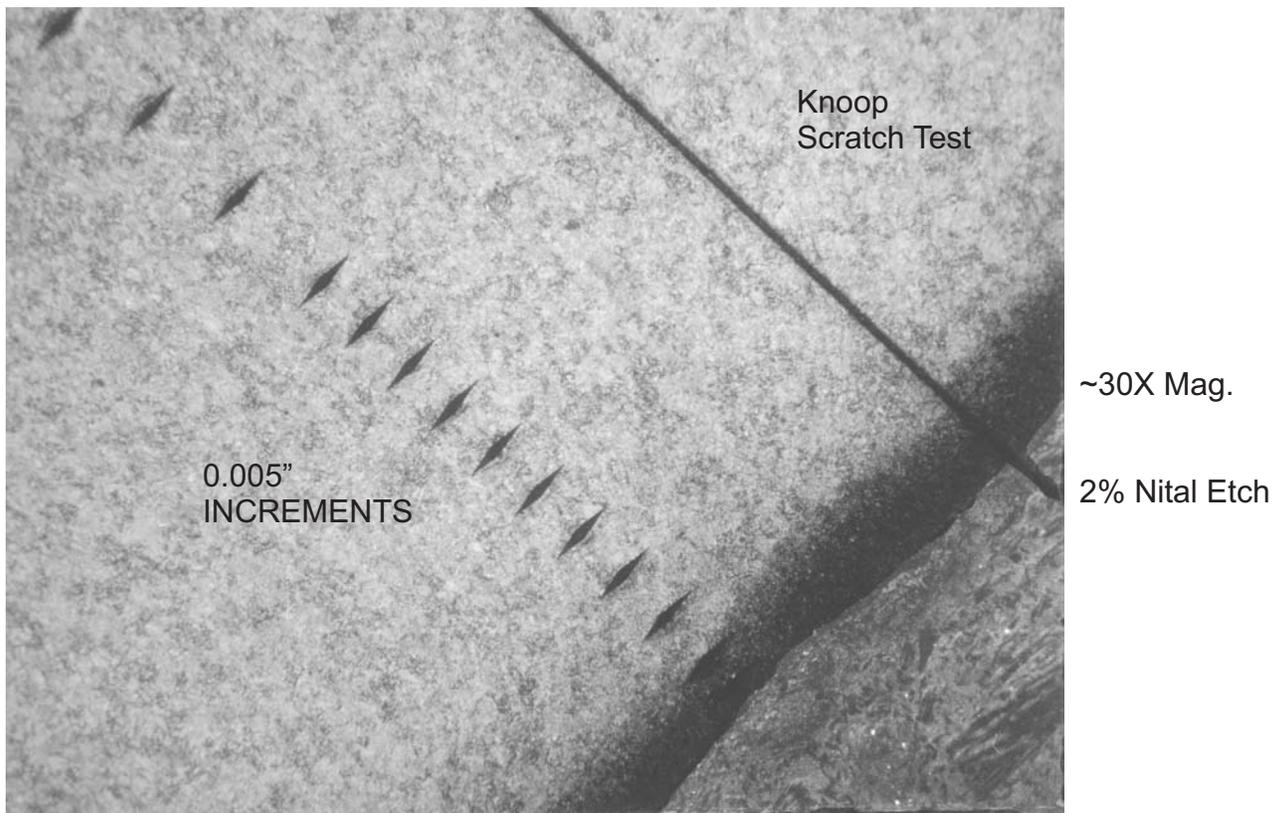
FIGURE 1. Random area selected for microhardness testing & scratch testing.

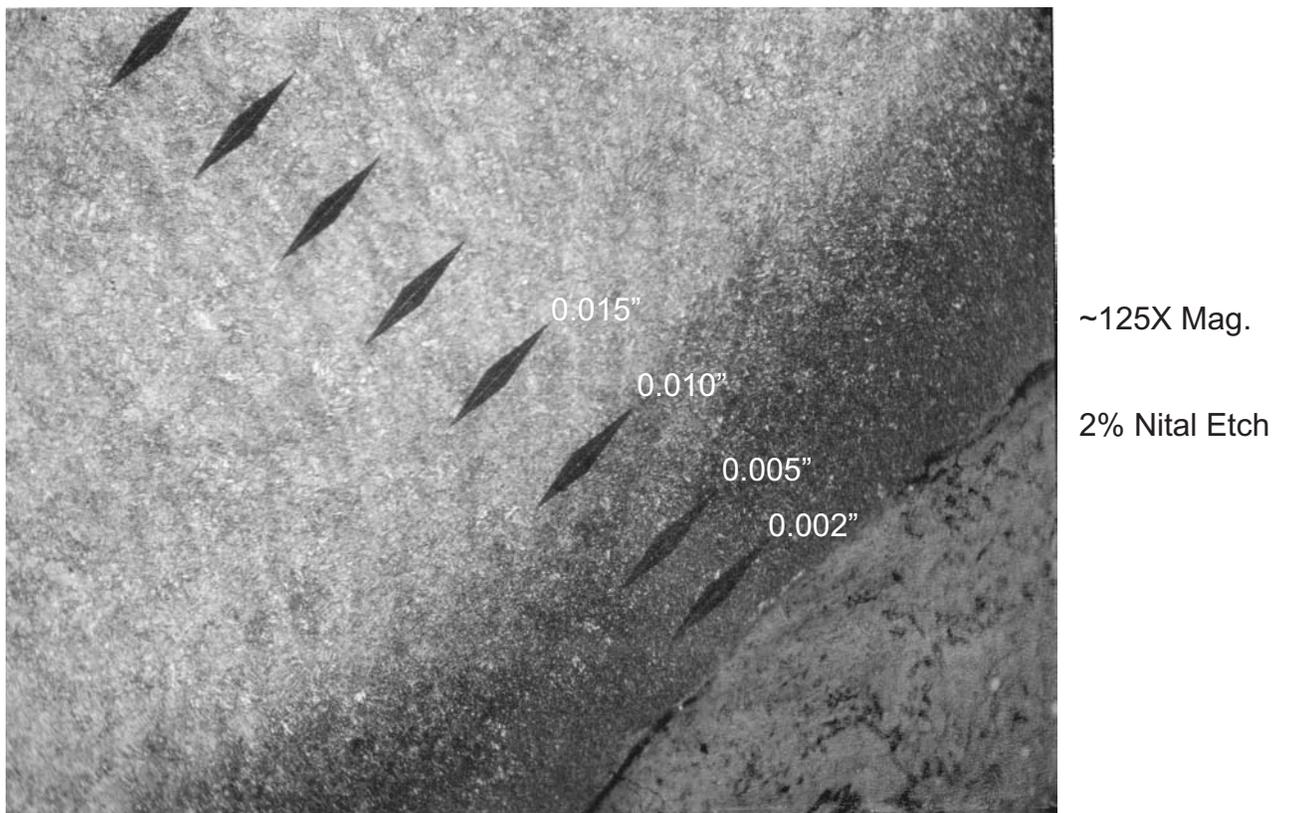
The microstructure of the carbon restored surface areas is tempered martensitic with a very fine dispersion of spheroidized carbide, as expected. The core microstructure is a coarser martensite. Because of dealloying, the carbon restored surface etches darker than that of the core metal.

FIGURE 2. At this mag., the carbon restoration extends into the metal ~0.010".

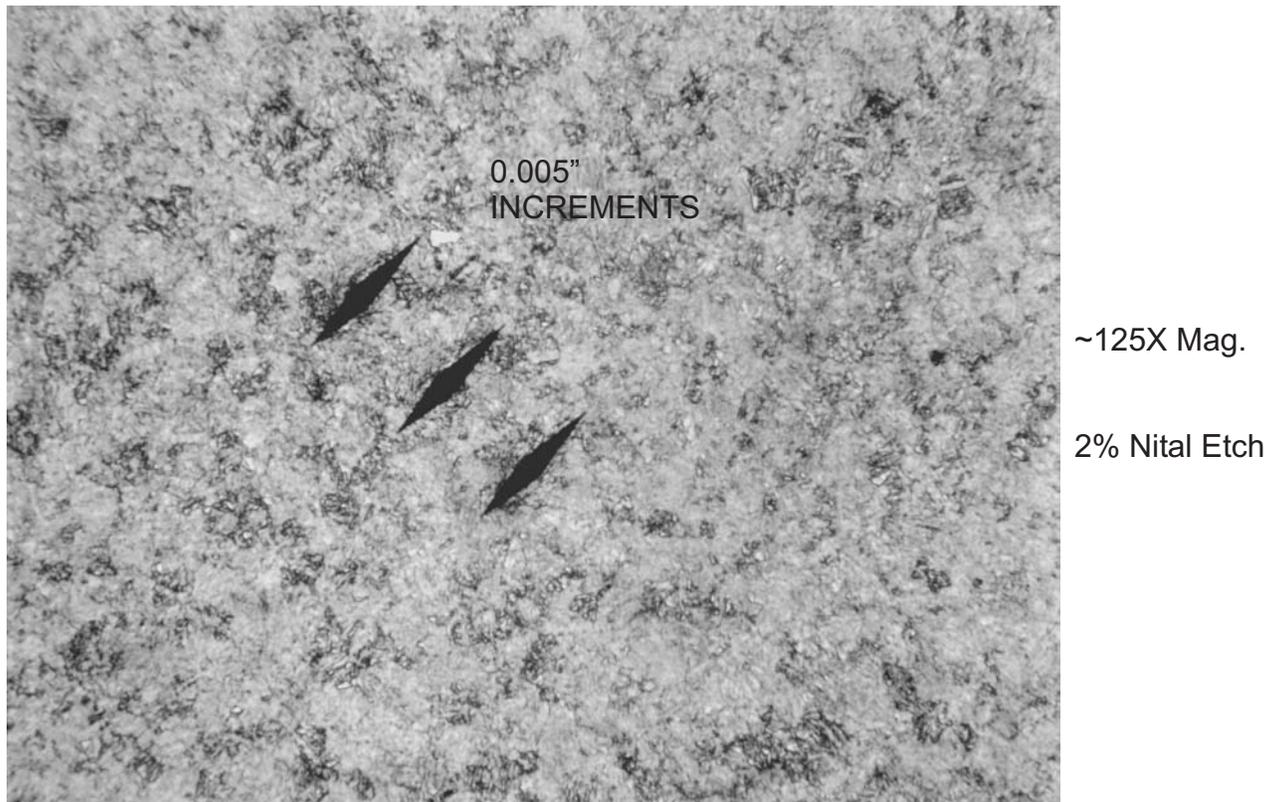
The Tukon-Knoop microhardness testing conducted shows the carbon restored surface areas are the same hardness as the core AISI 4130 alloy steel. This finding should lay to rest any concerns about the surface metal being wrongly subjected to a carburizing process.

FIGURE 3. This is a normal appearing martensitic microstructure expected when the metal has been normalized, quenched and tempered. The measured hardness is identical with that of the carbon restored surface.
