## Metallurgical Analysis of Cracked Tool

A cracked finger section was discovered in a plastic injection mold tool and sent to Tom Bertone for metallurgical failure analysis. A large crack had developed at the base of one finger. The tool is manufactured from a maraging steel. The metal was purchased from the mill in the solution annealed heat treat condition to accommodate machining. Following machining, the tool was given an age hardening heat treatment. The tool was placed into service and developed cracks at the base of a finger after about one year use. The metallurgical properties of this tool are to be evaluated for compliance to specification AMS 6514E.

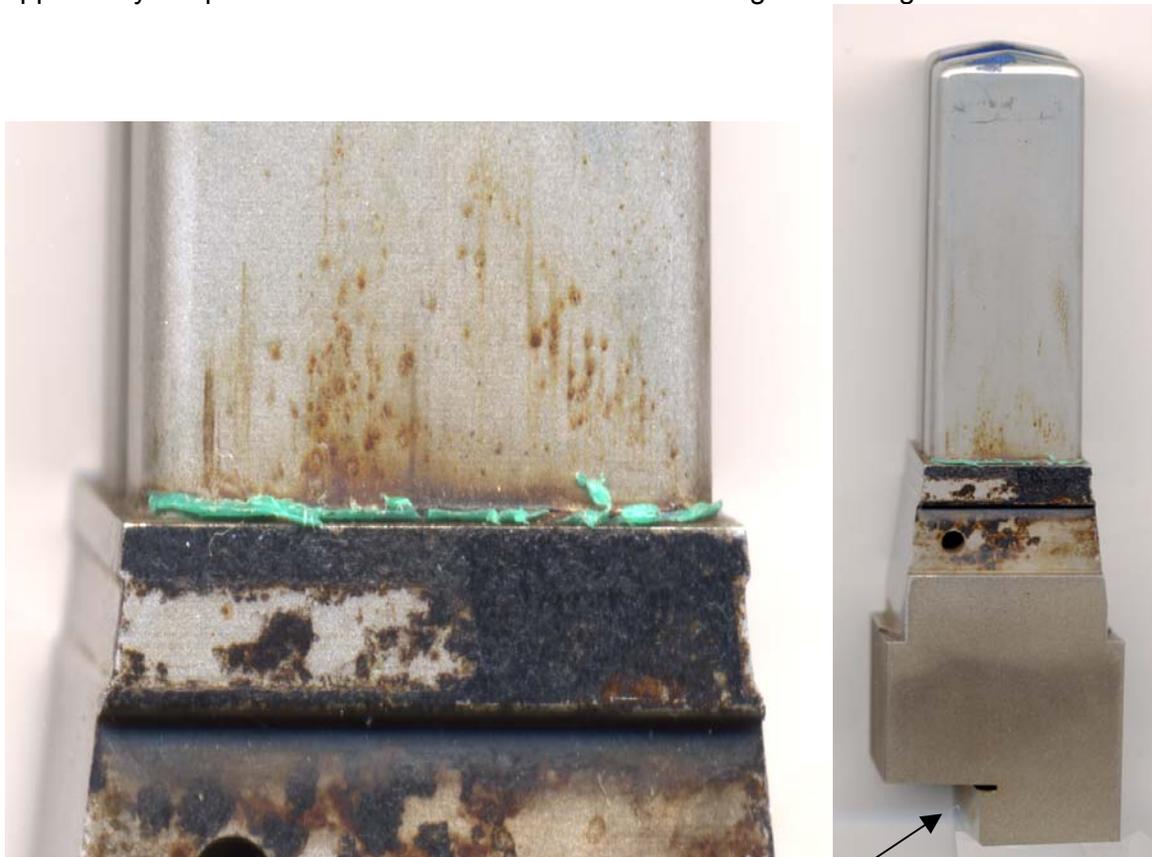
The crack at the base of one finger is much larger than that of the first tool and appears to be filled with green injection molded plastic; see Figure 1. The crack is much larger and extends nearly across the base area of this finger. A section of the base was removed for microstructure analysis and microhardness testing (see arrow). The size of the crack provides an opportunity to open and examine the fracture surface using a scanning electron microscope.

Figure 1. These photos show the condition of the finger as-received at TBC. The green plastic is lodged inside the crack as the base of one finger. The dark burnt areas appear to be residue from plastic and/or a mold release compound.

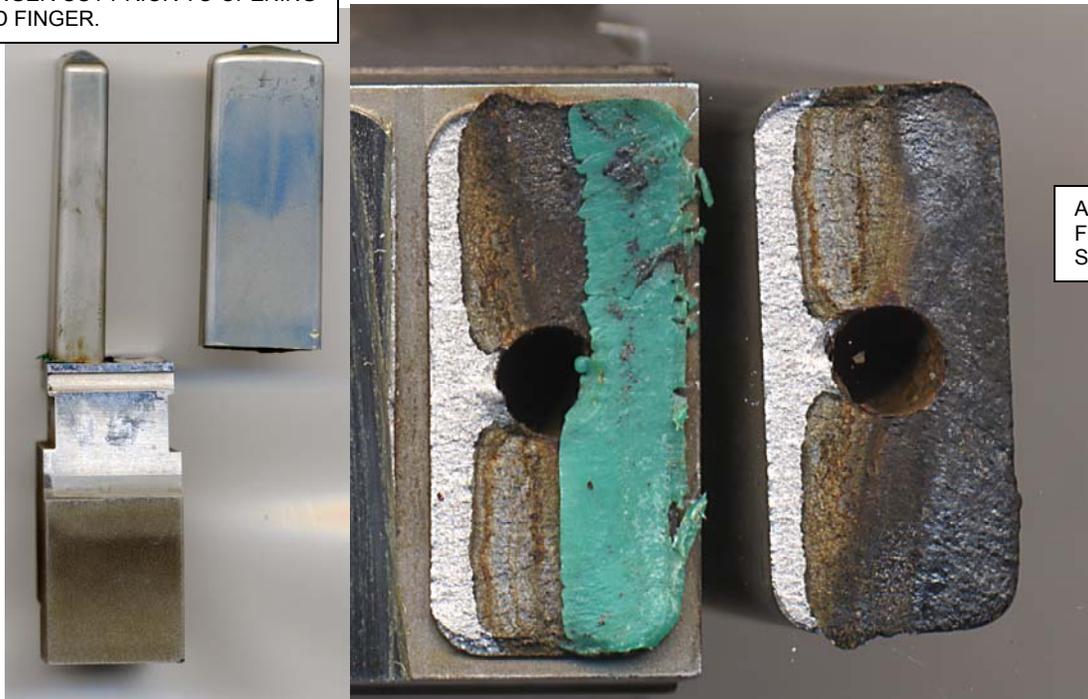
GOOD FINGER CUT PRIOR TO OPENING CRACKED FINGER.

AS-OPENED FRACTURE SURFACE

Figure 2. The uncracked finger was removed by wet sectioning as shown above. The base was clamped in a vice and the fracture finger was quickly bent to remove it; see bright silver fresh fracture. There is a pattern of progressive crack propagation on the fracture surface, evident buy rust colored corrosion. The black area appears burnt and smooth from plastic being injected and removed numerous times. Water has been leaking from the cooling hole; the interior of the hole is corroded. The coating of plastic was not bonded to the metal.

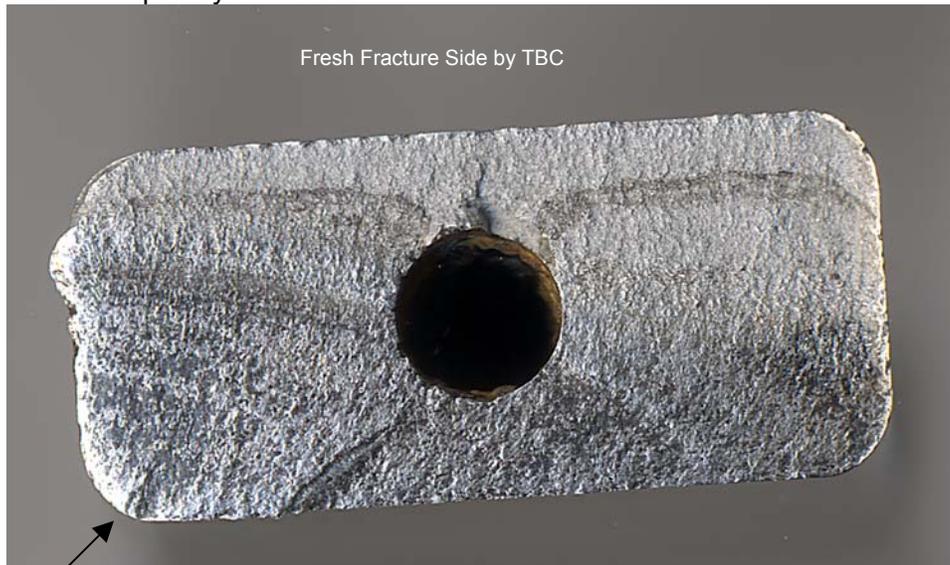
Figure 3. The arrow points to the location where fracture originated. The black carbon residue was scrubbed from the surface in order to see the fracture pattern. Fracture probably occurred due to notch sensitivity at the corner base of the finger or by sudden overload when processing parts.

Due to the burnt carbon deposit covering critical areas of the fracture surface, it was not possible to determine a fracture mode directly from the fracture surface without aggressively scrubbing. However, this was done, the pattern of fracture became clearer. The fracture origin is at a corner in the base radius. The crack progression appears to be caused by low cycle overstress and in simple terms, this means it appears the fracture began by impact and or sudden overstress by excess pressure. Upon cracking, the injection process was sufficiently forceful to cause the crack to grow quickly and propagate across the base of the finger. The tool began to leak once the cooling hole was compromised.

In the opinion of this metallurgist, the most likely cause of the crack is overpressure during operation of the tool. The fracture sensitivity and/or fracture toughness of the metal was not optimized, due to an insufficient or deficient Mill solution annealing heat treatment. The steel was purchased under the requirements of AMS 6514, however, the material supplier or the Mill, delivered steel which did not meet those requirements.

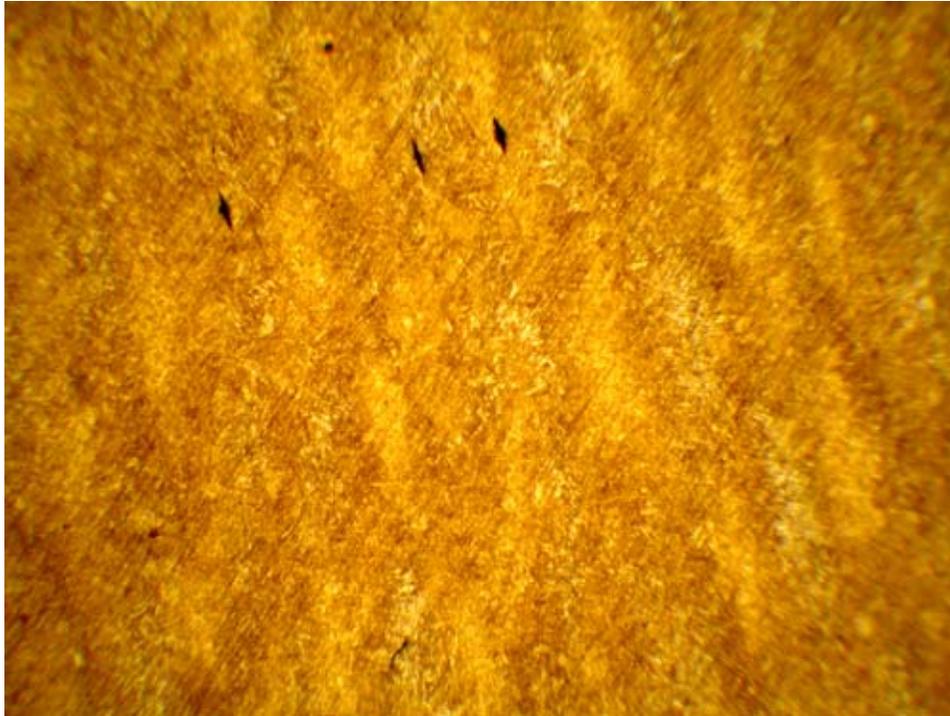
**Hardness Results:** The measured hardness is 51.6 – 52.7HRC.

Figure 4. The microstructure exhibits a fine micro alloy segregation. However, this indicates the metal is not properly mill homogenized, or this pattern would not be present. The micro alloy segregation is the pattern of lighter colored blotchy areas. A properly homogenized steel exhibits a consistent color or etched texture across the surface. The Knoop microhardness indentations are also visible.

Although the steel is purchased in the solution annealed condition, it would be wise to redo the solution anneal heat treat before machining.

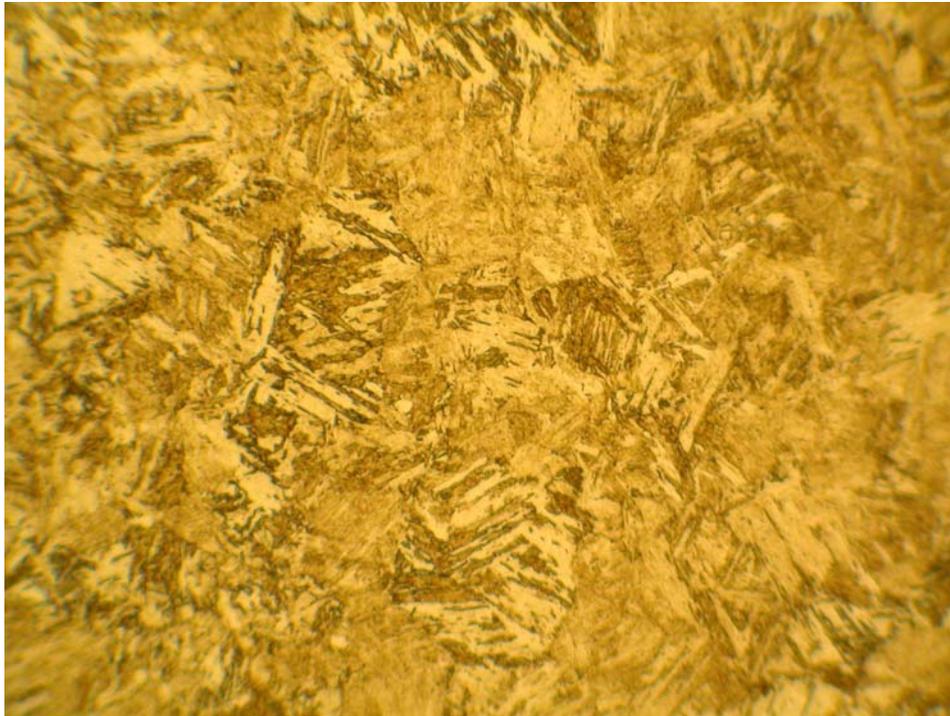
100X  
Mag.  
Kalling's  
Etch

This section was re-polished and etched with Kalling's etch and photographed; see Figure 5 below. The measured grain size is predominately ASTM 3-5.

Figure 5. This is the microstructure of the second failed finger; compare to Figure 6., below from the first report,

It is possible to make a comparison between the original first fractured finger and the second cracked finger from the same tool. They appear metallurgically identical except for the cell size of the micro alloy segregation. If this steel were subjected to another solution annealing, the grain size would be dramatically reduced in size.
