Case: AUTOMOTIVE ACCIDENT INVESTIGATION

Re: HEADLIGHT BULB FILAMENT ANALYSIS

Metallurgical Analysis

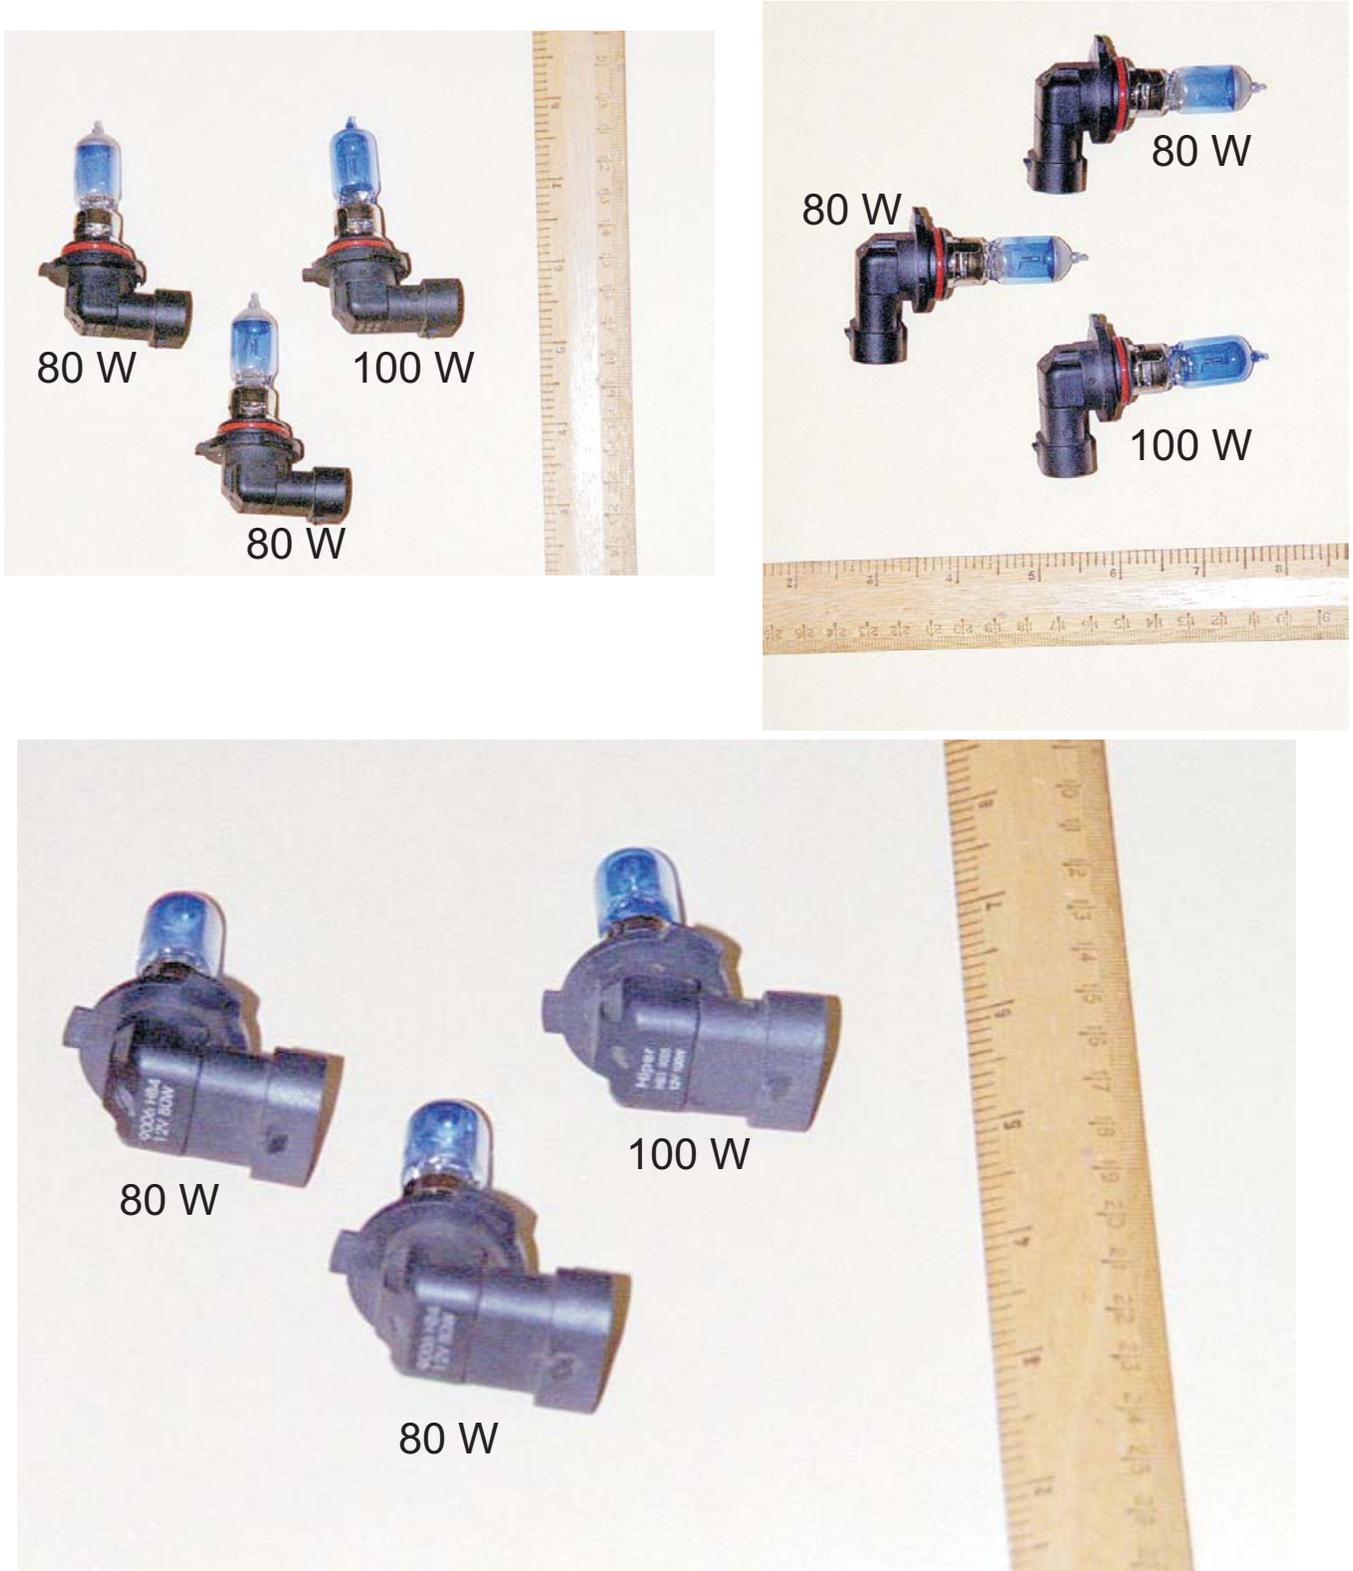
Figure 1. Lamps from Automobile Accident- Photos taken at ARB, Inc., by TBC showing different views and bulb identification.

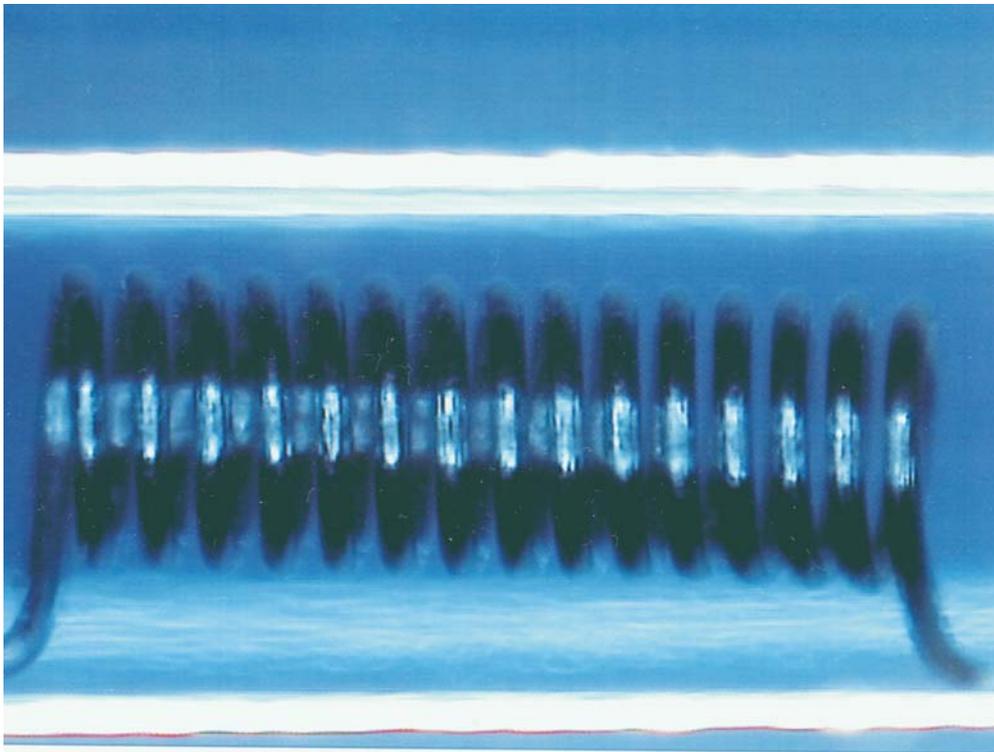
100 W Light Bulb Filament

In the opinion of this metallurgist, following macroscopic examination of the subject light bulbs, both 80W bulbs and the one 100W light bulb were "Cold or Not On" at the time of this accident. The brittle failure exhibited by the 80W light bulb tungsten filament was cause by "Cold-Snap".

Figure 3. Magnified view of the 100 W light bulb filament, showing the filament coils in near perfect condition. No hot stretch is evident and breakage did not occur.

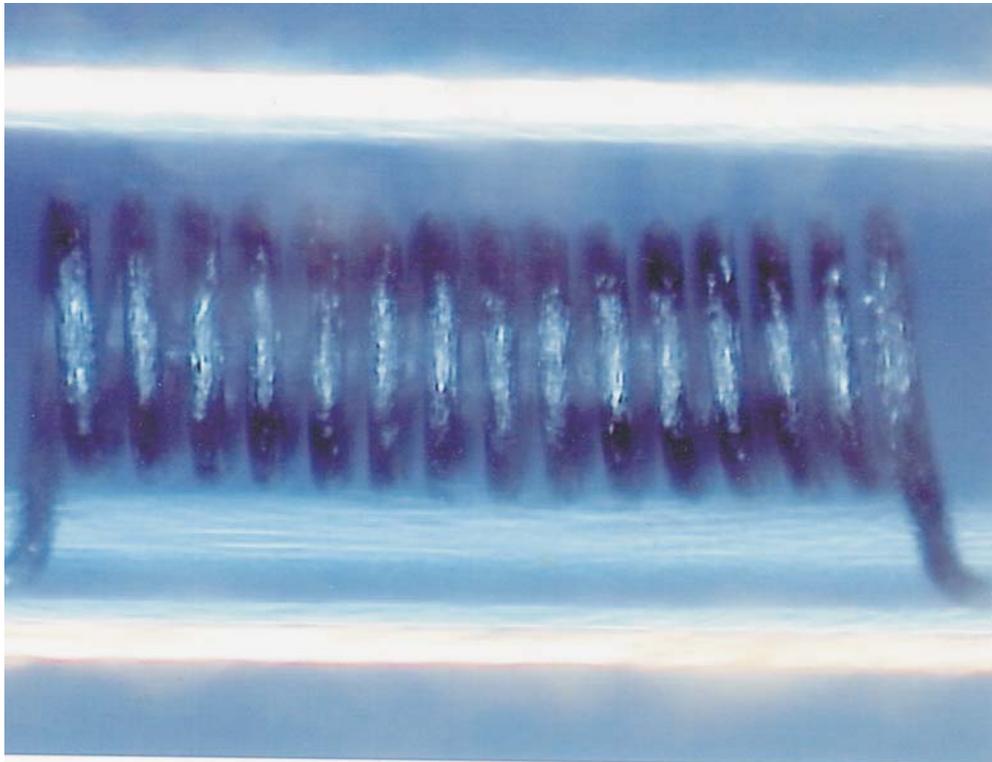
80 W Light Bulb Filament

Figure 4. Magnified view of the 80 W light bulb filament, showing the filament coils in near perfect condition. No hot stretch is evident and breakage did not occur. The rough surface is caused by normal crystal formation during use.

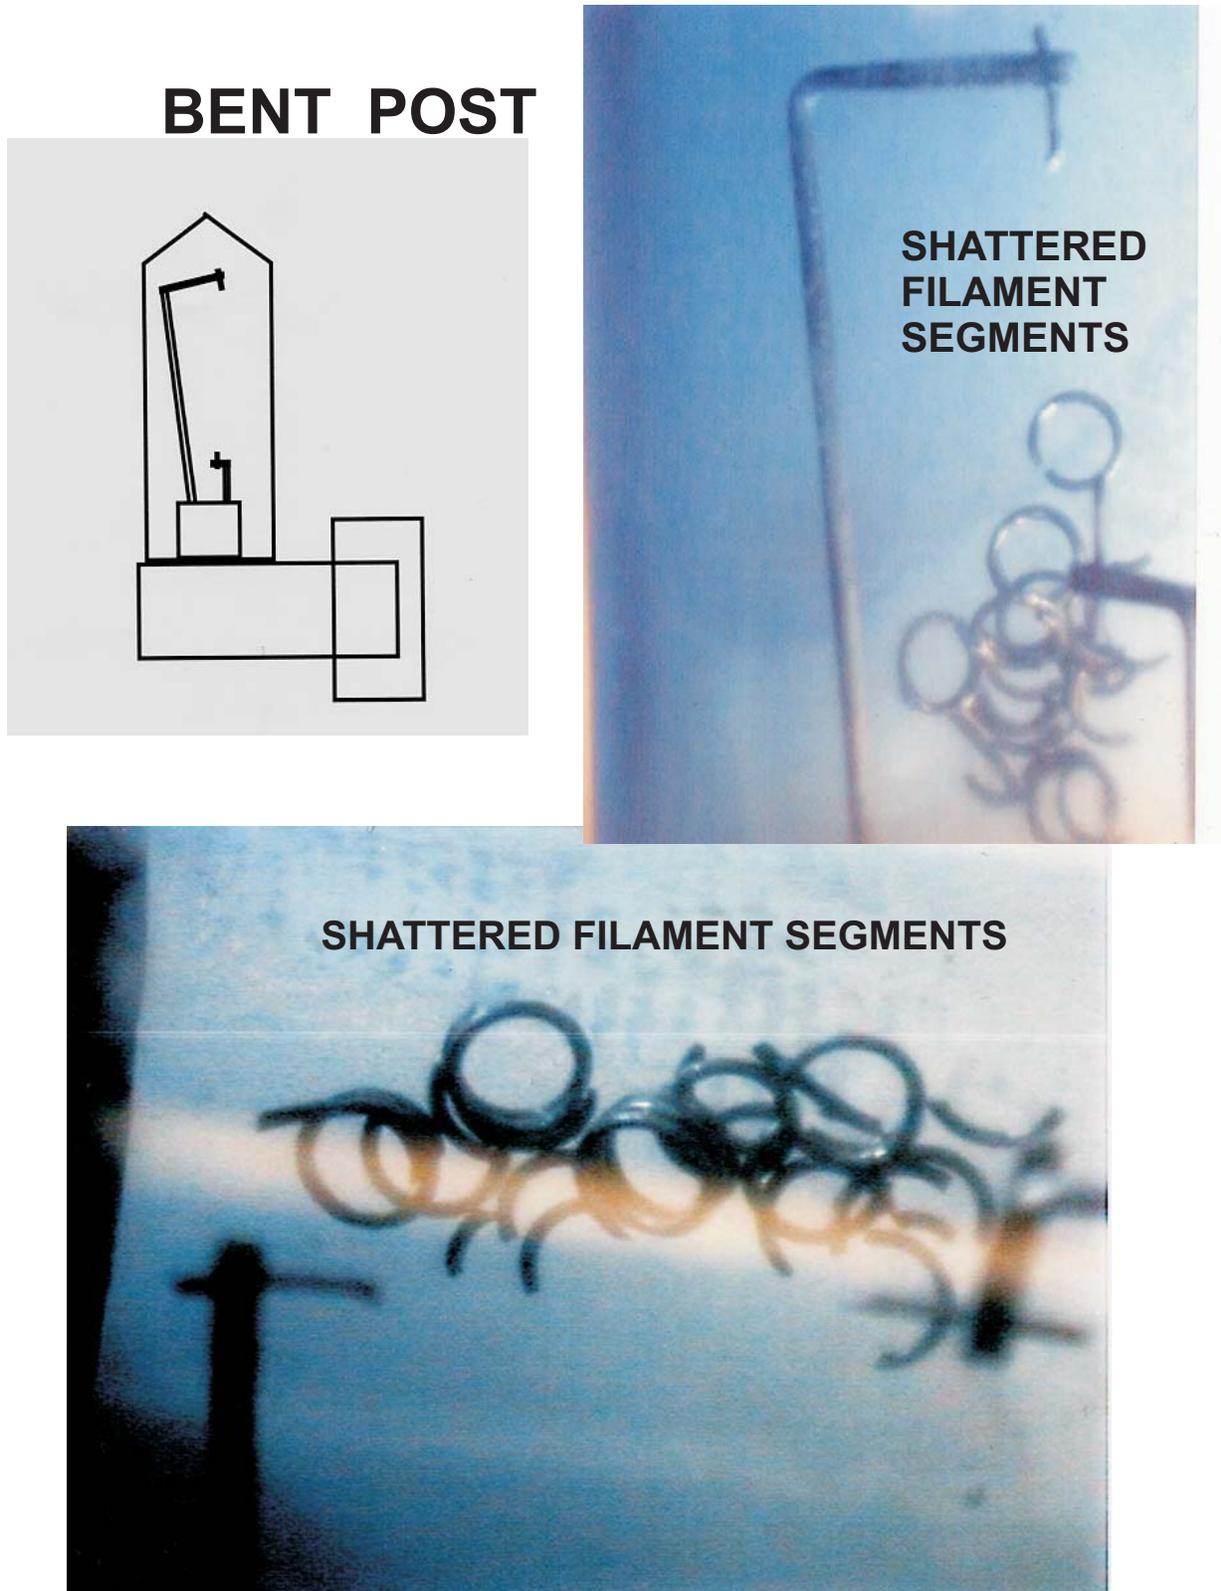
80 W Shattered Light Bulb Filament

Figure 5. Magnified view of the 80 W light bulb and shattered filament segments. No melting and/or stretch is evident when the filament broke (shattered). The schematic helps in viewing the bent post in the upper right photograph.

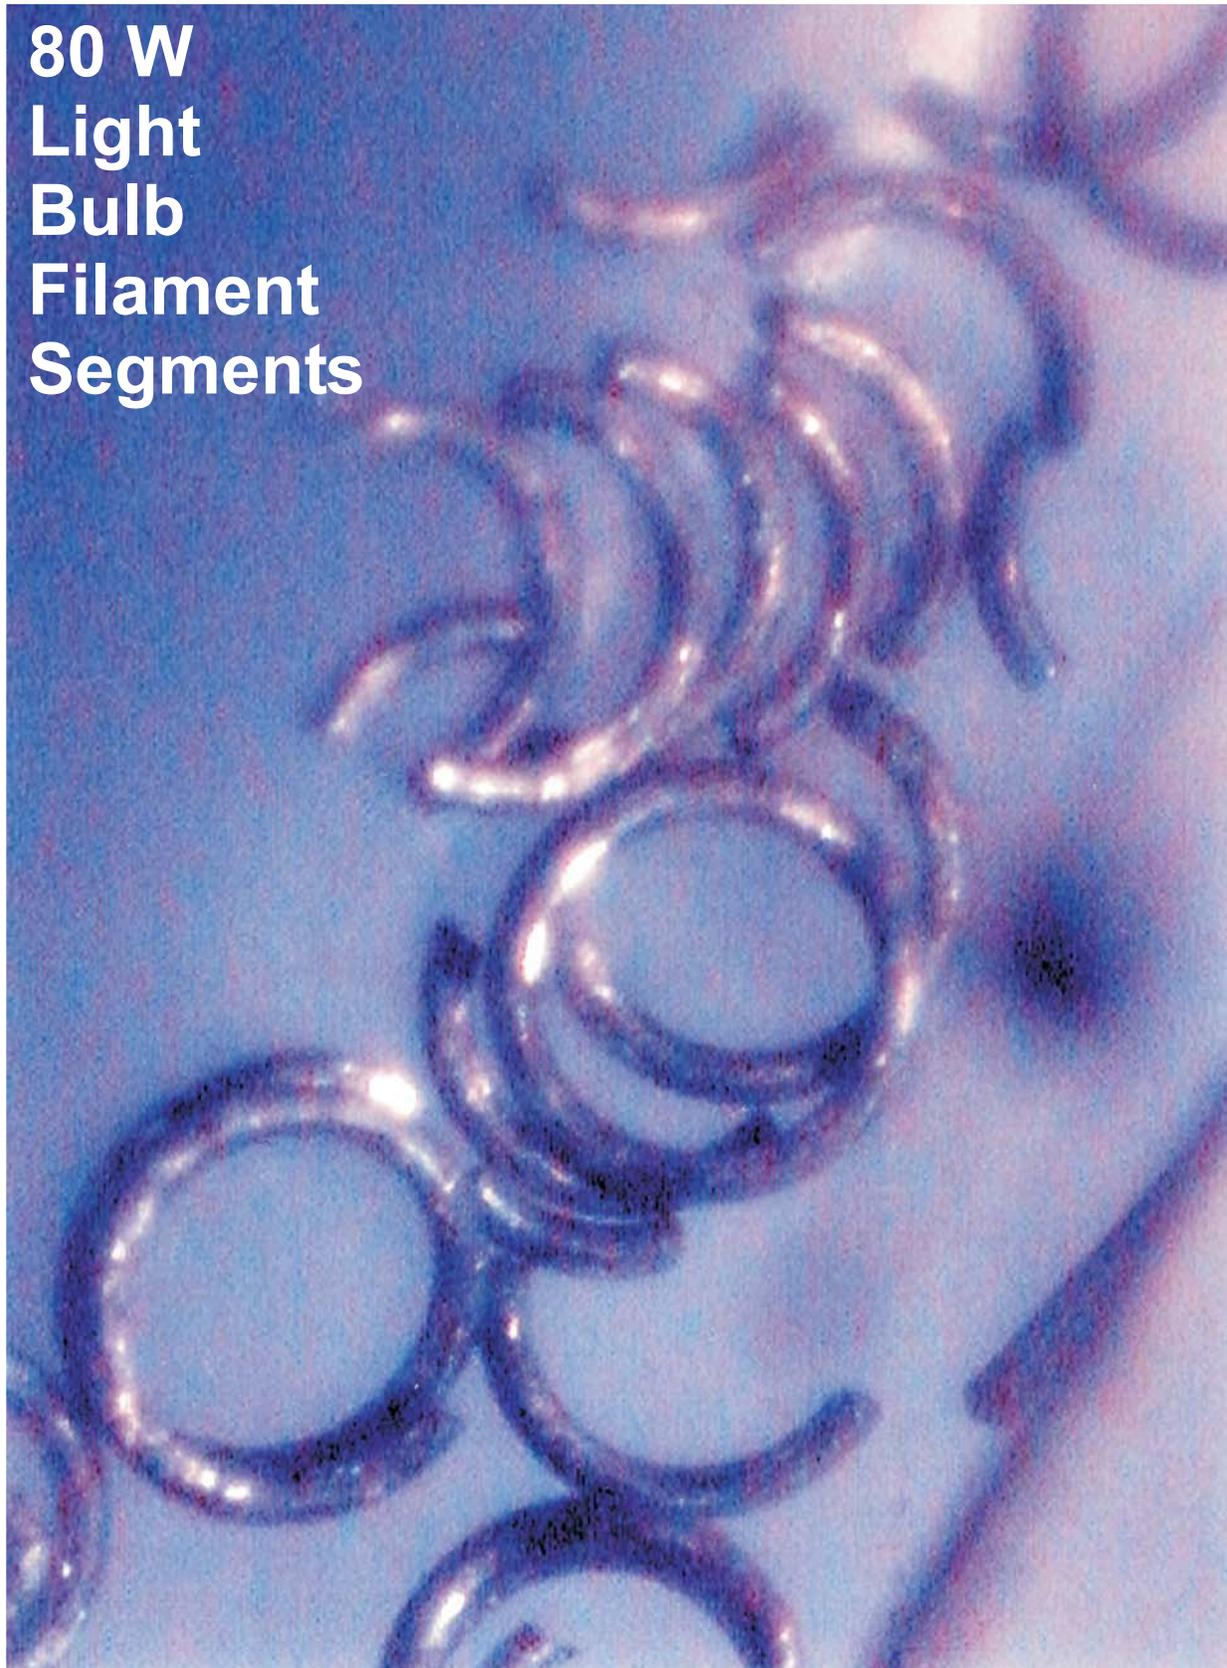
**80 W
Light
Bulb
Filament
Segments**

Figure 6. Magnified view of the shattered 80 W light bulb filament segments. Multiple brittle fracture occurred due to “COLD-SNAP” as a result of impact forces. Brittle shattering of the filament indicates the bulb was not on at the time of the accident.
