## Stub Axle Failure Analysis

A fractured stub axle was received for metallurgical failure analysis. The stub axle is fairly new and has a somewhat smooth fracture, beginning in the radius where the flange transitions to the bell. The fracture extended from this surface / corner inward and terminates at the corner of the inside drill cut.

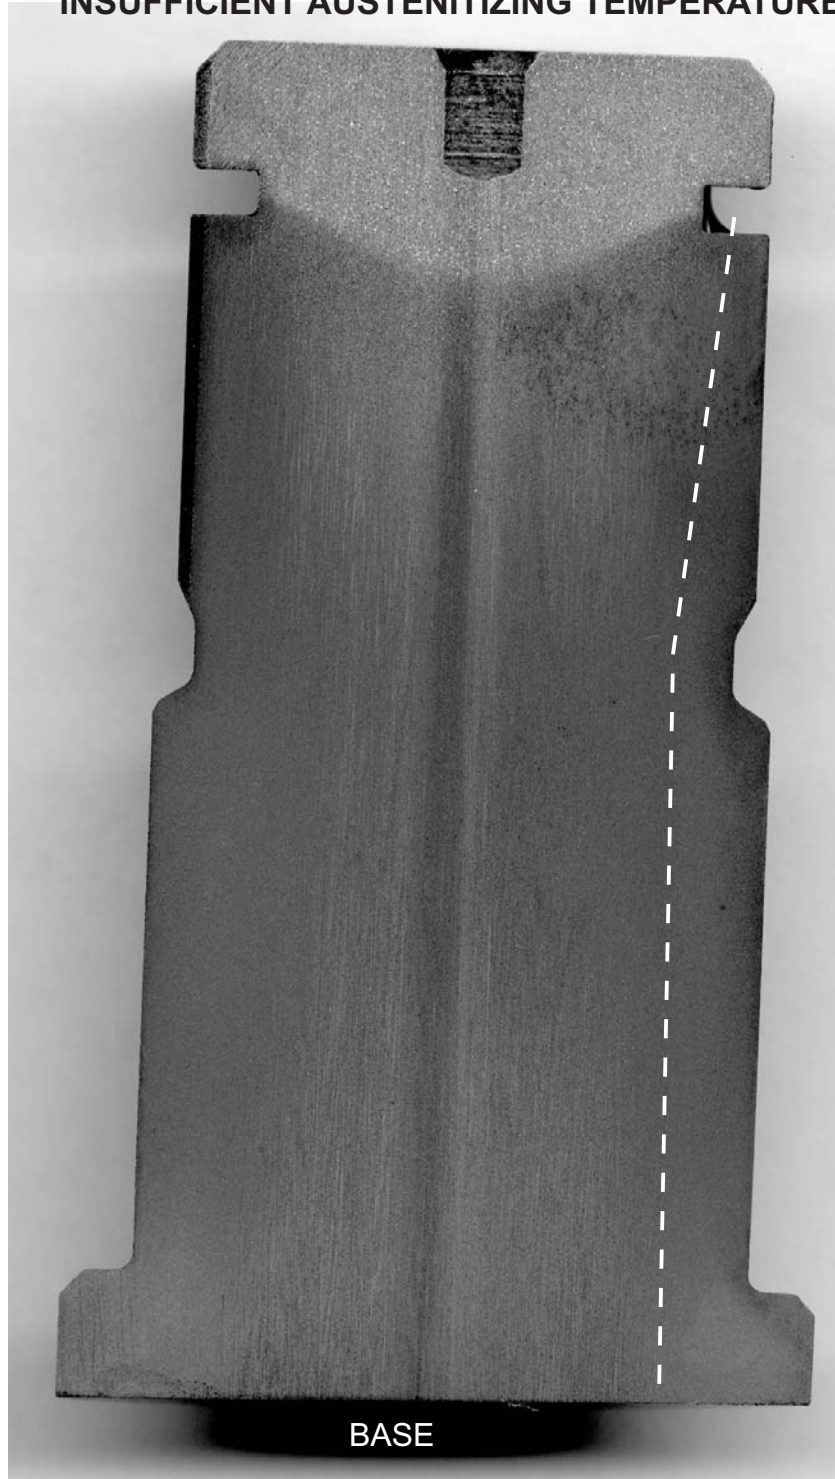
**INSUFFICIENT AUSTENITIZING TEMPERATURE**

**1. Macro-Etching:** The grain flow is unacceptably very fine and exhibits micro alloy segregation (banded grain structure); see Figure 1. As a result of an extremely fine banded grain structure, the mechanical properties of this section have been seriously compromised.

The measured hardness of this axle far too low, due to insufficient heating during induction hardening. The macro-etched section revealed the part was heated too long at too low of an austenitizing temperature. As a result, the microstructure is a mixture of ferrite and martensite and not one hundred percent tempered martensite as desired. A process procedure needs to be developed for the induction hardening process; specifying the parameters for correct heating and hardening.

FIGURE 1. The grain flow lines in the large section indicate an extremely fine grain structure which is micro-banded and was not normalized prior to being induction hardened. There is NO evidence of a CASE as expected when the surface is induction hardened: see dotted lines. The exemplar stub axle is hardened correctly; note the well defined induction hardened case.

1. Purchase order to mill must specify the following:
  - Material must be in the normalized and tempered condition
  - The grain size must be ASTM 3-7.
2. The radius, at the transition of the axle shaft to the bell, needs to be enlarged.
3. The correct temperature must be applied during induction hardening in order to correctly austenitize the surface before quenching. This axle was not induction hardened correctly. A process procedure needs to be developed specifying the parameters for correct hardening.

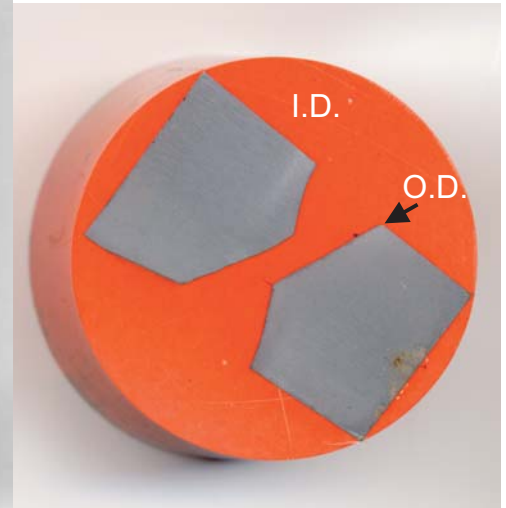
Lastly, there is a very outside diameter sharp radius where the stub axle transitions to the bell. This sharp radius needs to be enlarged to reduce localized fatigue over-stress. The fracture originated at this outside diameter radius and propagated inward due to excessive over-stress.

The orange mount contains the etched cross-section of the fracture surface examined in Figures 2 and 3. These pieces were cut from the base of the stub axle which intersects the bell. The arrow points to the sharp corner and lack of a sufficient radius.

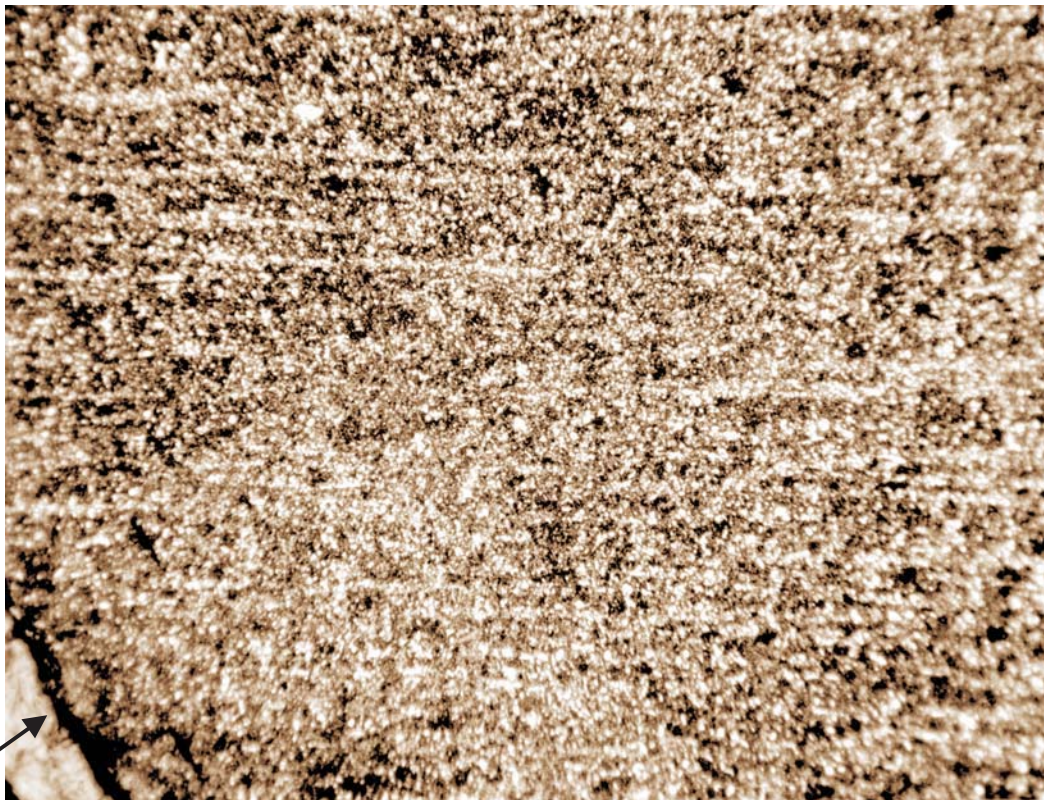
**4. Microstructure Analysis:** The microstructure is mixed tempered martensite and ferrite; see Figures 1 & 2. Transformation to martensite has not been complete; material exhibits micro alloy segregation or banding due to not being normalized prior to hardening. The grain size is extremely fine, much finer than ASTM 10. The metal has not been heated sufficiently at the required austenitizing temperature with the correct settings for surface induction hardening. A partially hardened microstructure is evident throughout. no case hardening is evident; see example in Figure 1.

FRACTURE SURFACE

FIGURE 2. Arrow points to the fracture surface. The microstructure contains ferrite when it should be fully martensitic. Micro-banding is evident and the grain size is extremely fine <ASTM 10.

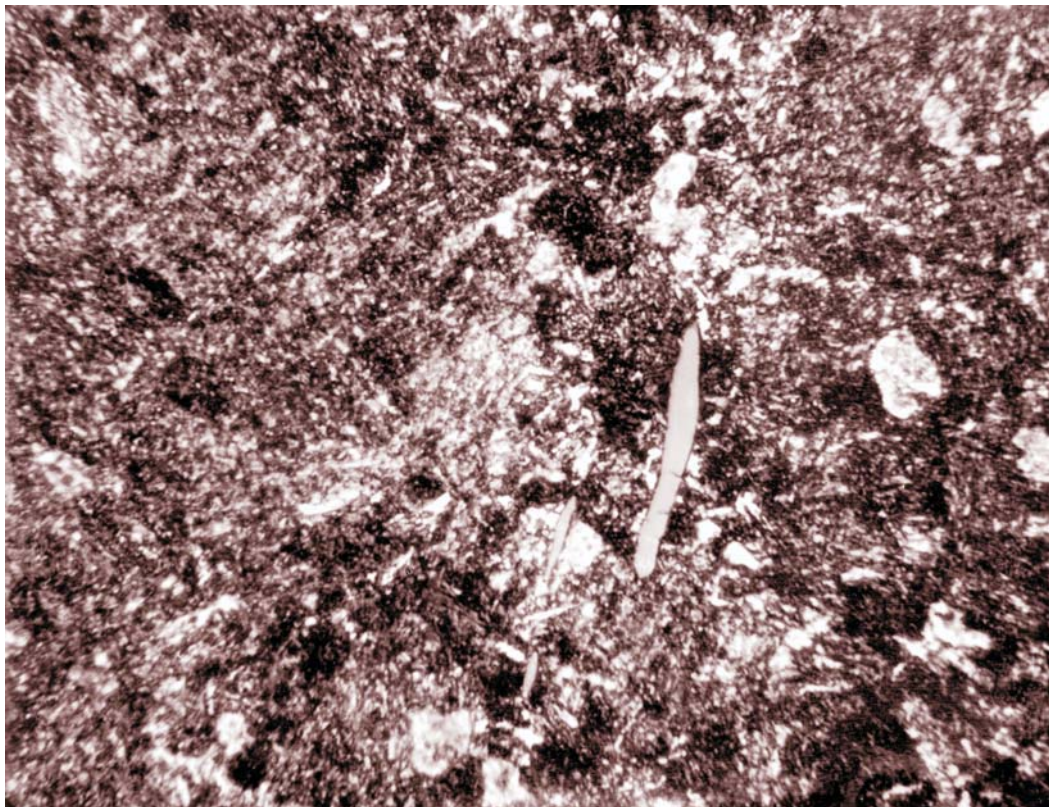
FIGURE 3. Arrow points to the fracture surface. The microstructure is blotchy due to ferrite and incomplete martensitic transformation during induction hardening.
