Case: AUTOMOTIVE ACCIDENT INVESTIGATION

Re: HEADLIGHT BULB FILAMENT ANALYSIS

Metallurgical Analysis

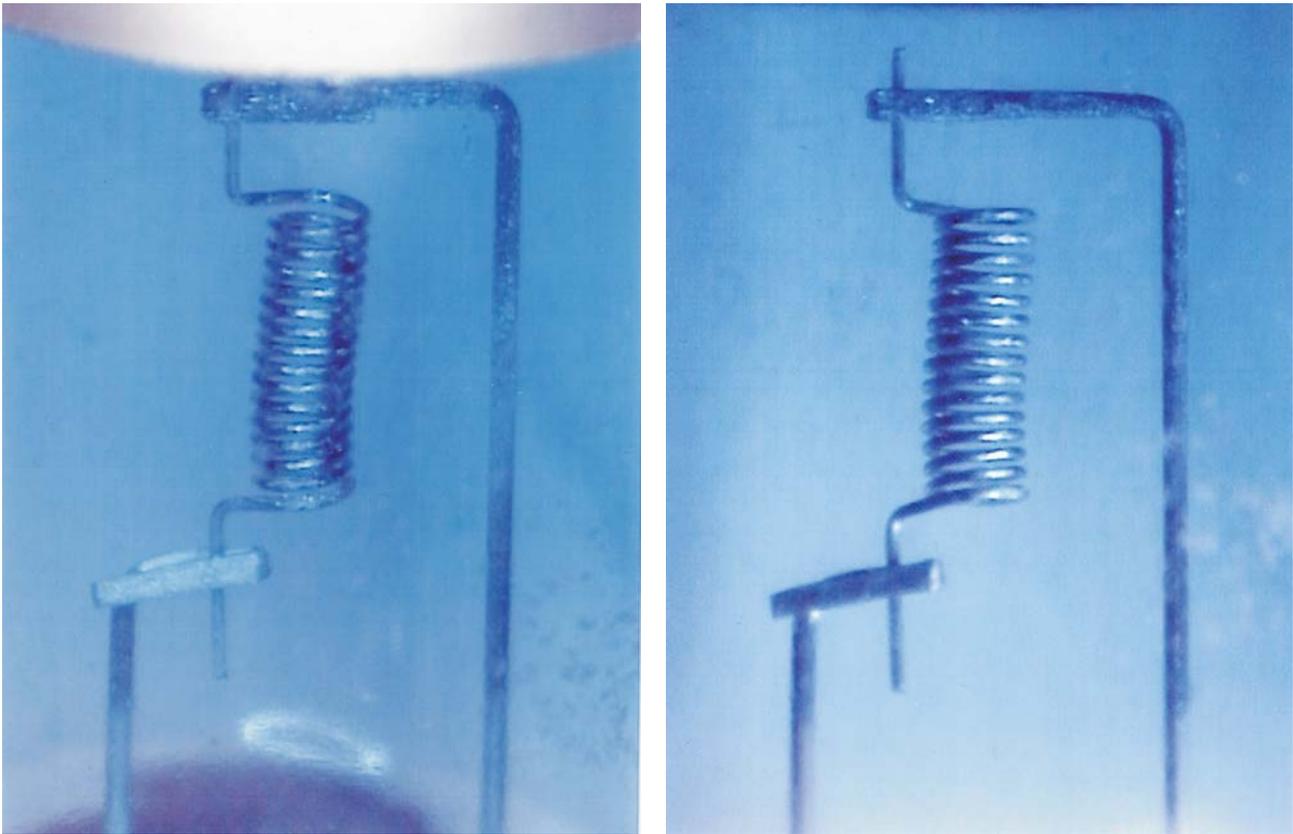
80 W Light Bulb Filament

Figure 4. Magnified view of the 80 W light bulb filament, showing the filament coils in near perfect condition. No hot stretch is evident and breakage did not occur. The rough surface is caused by normal crystal formation during use.
